Structural health assessment of a historical building by using in situ stress wave NDT: a case study in Iran

Mehrab Madhoushi^{1*}, Saeideh Ebrahimi¹, Asghar Omidvar¹

The aim of this study was to undertake the in situ evaluation of structural wood member in a historical building (Reza-Nejad) in Gorgan, Northern Iran using stress wave non-destructive testing (NDT). The Reza-Nejad was built approximately 80 years ago. This study is the second one after that conducted by (Madhoushi, 2016) on the use of non-destructive testing (NDT) for the investigation and health assessment of historical wooden buildings in Iran.

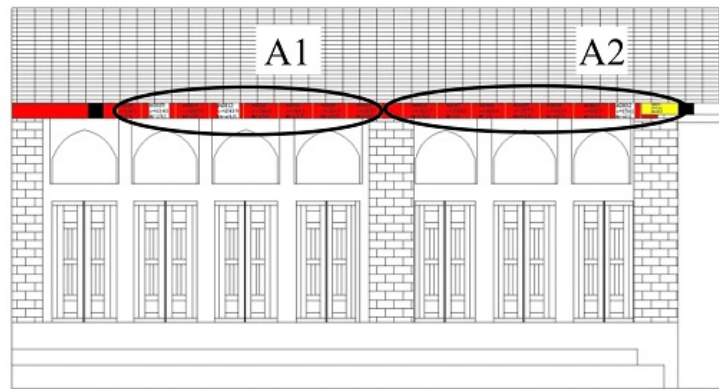
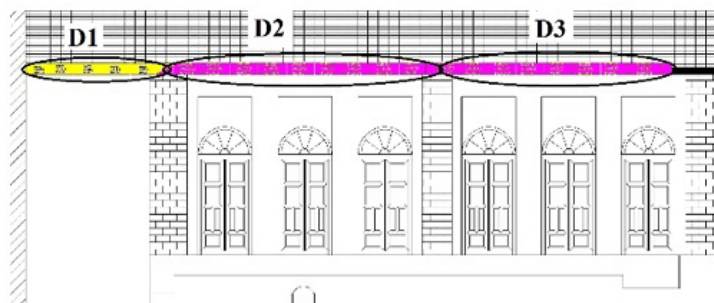
(a) Section A-A East,

(b) Section B-B North,

(c) Section C-C West,

(d) Section D-D South,

Fig. 6 Main plans of four sections of buildings and wood beams in a) A, b) B, c) C, and d) D (see Fig. 1 for more details).

Microscopic identification of samples showed that the load bearing wooden parts of the building were made of hardwood species native to the northern region of Iran including oak (*Quercus castaneaefolia*), lime tree (*Tilia begonifolia*), acer (*Acer insigne*), and beech (*Fagus orientalis*). Fig. 4 and 5 show the microscopical sample for transverse and tangential sections, respectively. The location of wood species in the building is shown in Fig.6 and Tab. 2.
